# COUNTERMEASURE

SEPTEMBER 2000

# ARMY GROUND RISK-MANAGEMENT PUBLICATION COUNTERMEASURE

The Official Safety Magazine for Army Ground Risk-Management

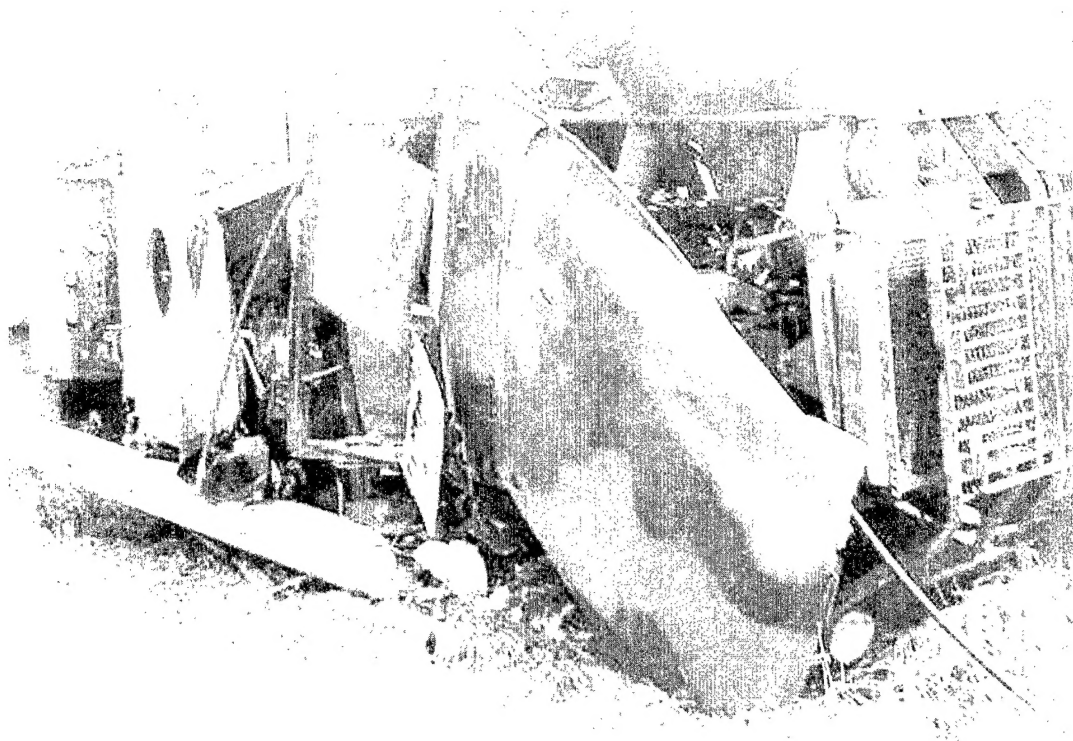
A passenger was killed and the driver injured when their 5-ton truck went out of control and ran into a utility pole. The vehicle was part of a unit convoy that was en route to a training site when the driver over-corrected his steering while swerving to avoid hitting a civilian vehicle to his immediate front. The civilian vehicle had swerved to avoid a pedestrian who was near the road. The 5-ton driver was following too close to the civilian vehicle for the conditions on the road.

**Hazards.** The driver failed to maintain sufficient separation between his vehicle and the civilian vehicle. His speed was between 20-25 miles per hour with only 25 feet separation.

The 5-ton driver was following too close behind another vehicle when he lost control and hit a utility pole. The passenger was killed.

**Controls.** Convoy commanders must ensure all drivers are briefed on convoy intervals and speeds. Further, they must brief all members of the

convoy on local traffic laws and customs. Finally, leaders must enforce standards for safe driving among all their subordinates.

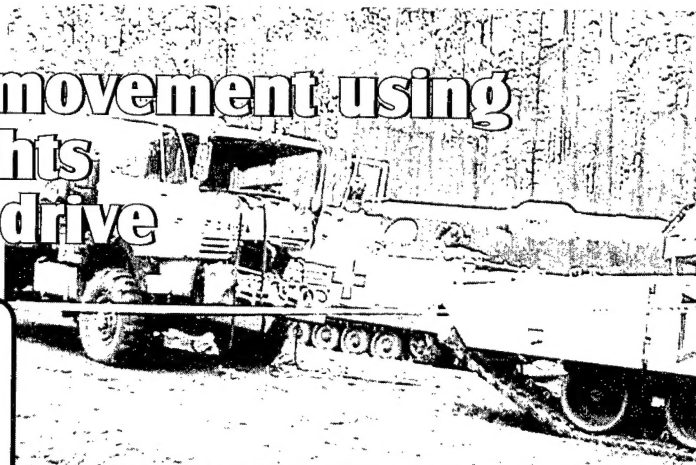
The LMTV struck the stationary tank. The forward-pointing gun tube of the lead tank penetrated the crew cab of the LMTV and struck the driver, fatally injuring him. Other personnel in the LMTV suffered minor injuries. No one in the tank was injured.

The TC of the lead M1A1 did not operate his vehicle in accordance with command directives. He did not operate his vehicle with blackout drive lights and other illumination requirements.

The LMTV senior occupant did not execute his responsibilities to ensure safe vehicle operations. He failed to ensure the driver or the truck commander had and used NVDs for the night movement. Consequently, the unaided LMTV driver could not see the unmarked, unlit lead M1A1 tank and ran into it head-on.

The installation range regulation deals specifically with convoys using IR drive lights. It requires both the lead vehicle and the trail vehicle to use blackout drive lights and that vehicles using IR illumination be also illuminated with an additional light source such as a chemical light. Personnel in the front and trail vehicles are to warn approaching vehicles of IR vehicle operations.

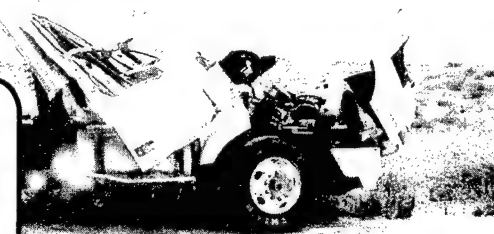
The vehicle was traveling between 55 and 65 mph as it entered the curve. The driver lost control of the vehicle midway through the curve. The tractor and trailer rolled 270 degrees to the left (driver's side), ultimately

The TC for this mission failed to maintain control over the driver's actions and did not perform his duties as outlined in AR 600-55. Witness statements and analysis of the accident site indicate that the vehicle was traveling at a high rate of speed for the conditions.

- Reduce speed for conditions
- Effective control of vehicle by TC
- Proper risk management procedures
- Leader involvement in daily operations
